Smart-Alek® Case Study #1

Inaccurate Chart Measurement at Gas Well

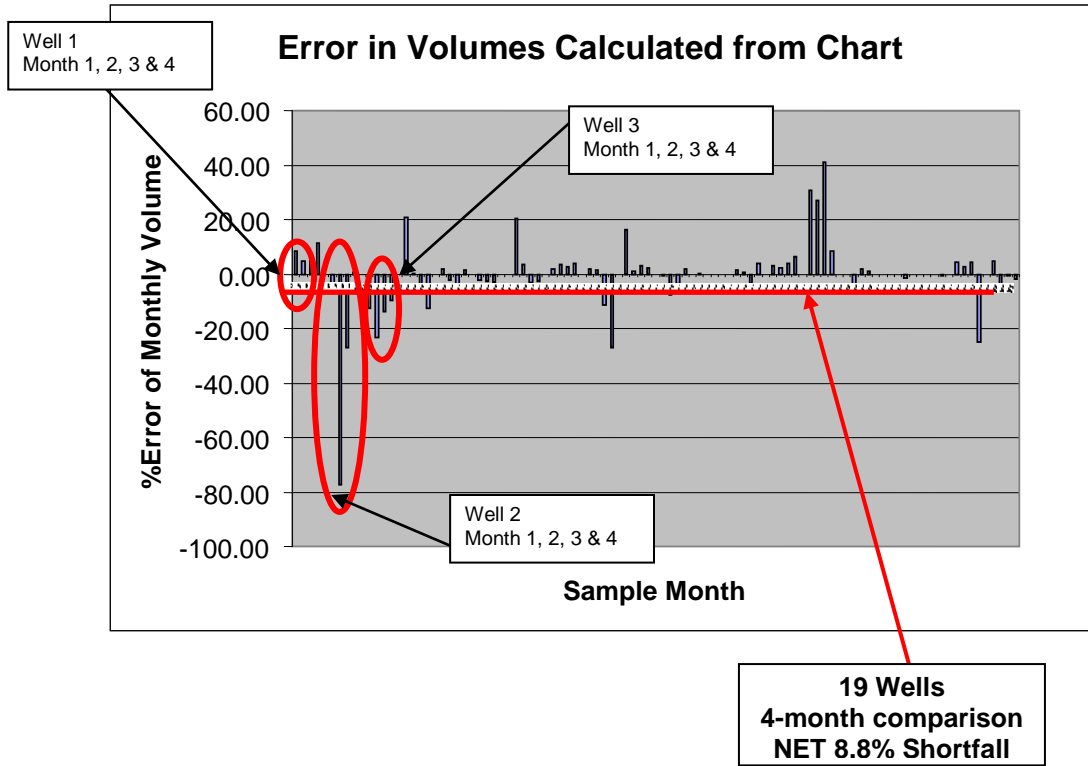
Figure 1 – Volume Measurement Error with Chart vs. Zedi’s Smart-Alek

Over a pilot period of four months, charts and the EFM were compared. The Company showed a +9% aggregated average volume for 19 wells compared to mechanical chart volumes (see Figure 1). This created an increase in allocated production and helped improve a critical business issue of inaccurate gas measurement.
